# THE OPTIMIZATION OF BUILDING DECONSTRUCTION FOR DEPARTMENT OF DEFENSE FACILITIES: FT. MCCLELLAN DECONSTRUCTION PROJECT

Bradley Guy<sup>1</sup>

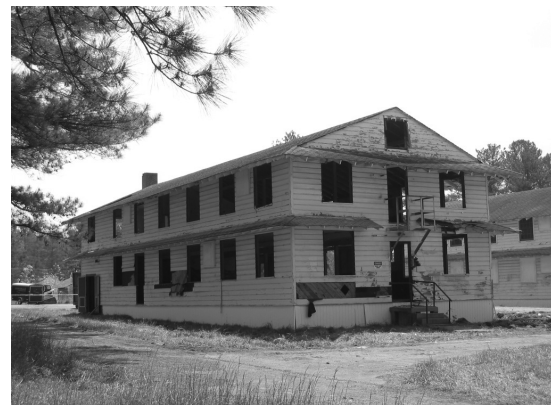
**PHOTOGRAPH 1.** Typical case study building at Ft. McClellan Army Base

The buildings used in this study were comprised of raised floor system, balloon-framing, and roof rafters with joists, and were approximately 30' wide x 73' long. At one end was a slab-on-grade boiler room and common bathroom facilities at each floor. The other three-quarters length of the building was a single open room on each floor, with partial height partitions to form cubicles.

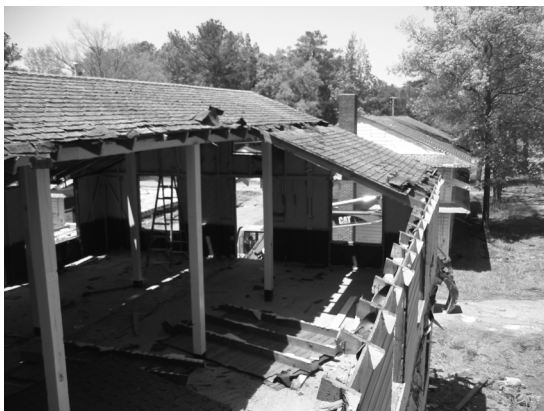
**PHOTOGRAPH 2.** Roof panelization

*Lift (HS)* was a technique uniquely applied to the roof structure using a crane to lower a section of roof to the ground where its constituent materials were separated by hand.

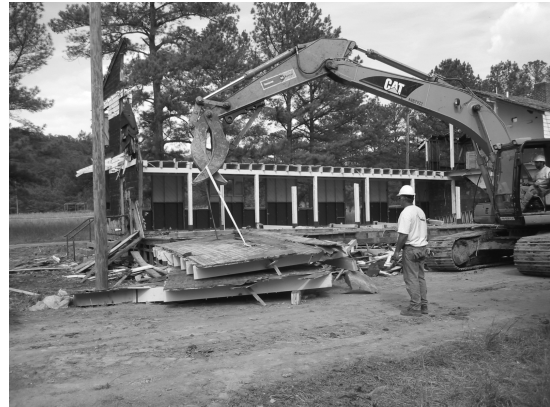
**PHOTOGRAPH 3.** Second floor panelization and lay-down for hand disassembly

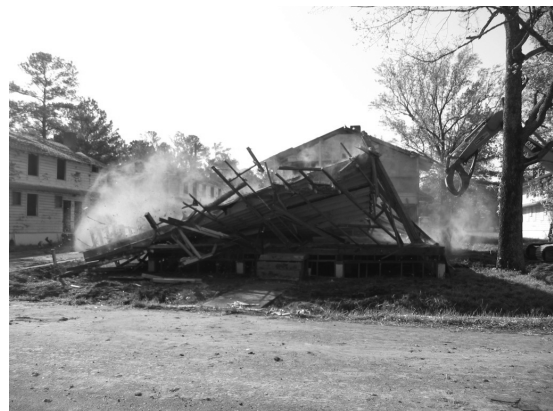
**PHOTOGRAPH 4.** “Dropping” second floor by collapsing onto first floor

*Drop (HS)* was a technique applied to the second floor structure in which a controlled collapse of

the second floor was used to facilitate the hand separation of its constituent materials.

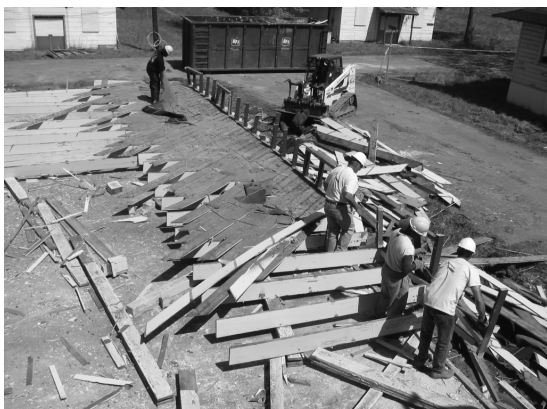
**PHOTOGRAPH 5.** Hand disassembly of dropped second floor
