Used Building Materials & More

Case Study Report #4, 520 Ridgeway Bellingham, WA 5-Bedroom Residential Dwelling, Circa 1970

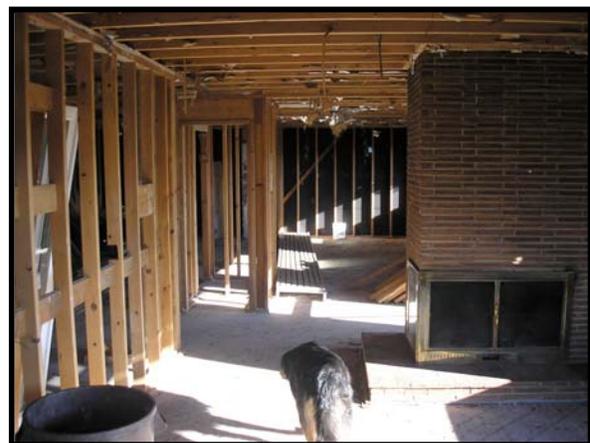
Once the interior was thoroughly gutted, the roof was ready to be removed. At first inspection, the roof of 520 Ridgeway was thought to be comprised of only one layer of composite shingles, which were quickly and easily removed. However, an additional layer of torch-down roofing was found beneath the top layer of shingles that was untested for asbestos. After samples were taken and tested by an outside contractor, it was determined that there was asbestos present in the felt paper beneath the torch-down, and abatement was scheduled and work ceased on the roof structure, until abatement could be completed.

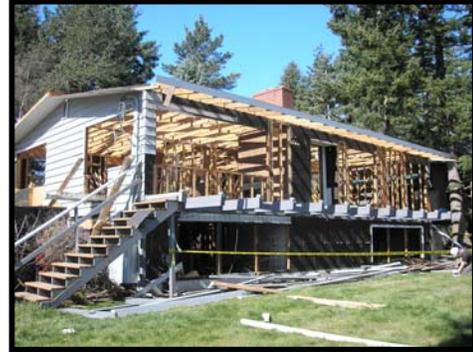
Abatement was completed over the following weekend, so work could be continued on the roof structure of the house the following Monday. Using “bangers,” a type of slide-hammer nail-puller, three members of the field crew worked on the roof to remove the nails from the shiplap sheathing, which was determined to be in good enough shape and easy enough to de-nail that it was worth salvaging. Once the nails were all pulled, the lengths of shiplap were passed down to waiting crew members who de-nailed and stacked the material according to length, in anticipation of a focused load-out.

- Note that every effort is made to keep like lengths of materials together throughout the deconstruction process to maintain de-nailing, loading, and measuring efficiency.

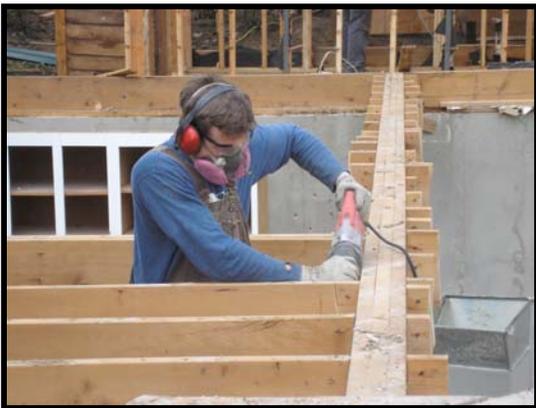
Once the ceiling joists and rafters were completely exposed, they were cut at the point they connected with the exterior walls and processed for denailing and load-out in the same manner as the shiplap sheathing.
