Case Study Report #3, 314 Bayside Rd. Bellingham, WA
2 Bedroom Residential House, Circa 1950

Site Description:

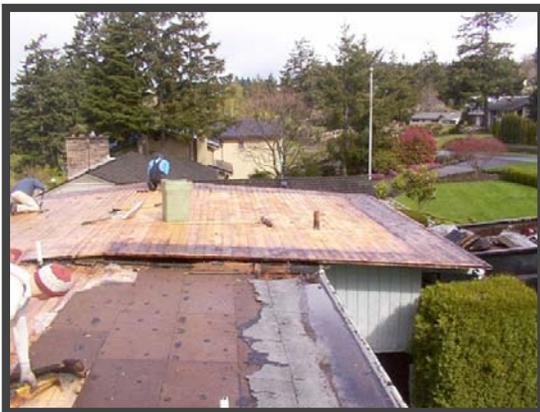
Roof: The roof of the house was composed of several layers of torch-down roofing affixed to the above-mentioned layer of car decking, supported by a beam running the longitudinal length of the structure and beams transverse to the main support beam. The roof of the carport was built similarly: car decking supported by post and beam construction.

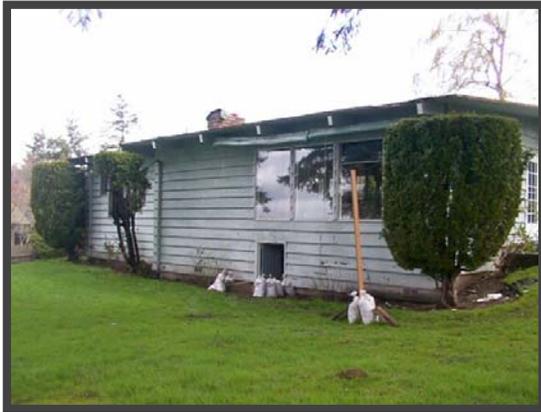
Exterior: The exterior of the house was sided with cedar over recyclable coconut fiberboard and was estimated to be 80-90% salvageable. The carport was also sided with cedar and was also estimated to be 80-90% salvageable. Between the two buildings, it was expected that over 2000

linear feet of beveled and “drop” cedar siding should be salvaged.

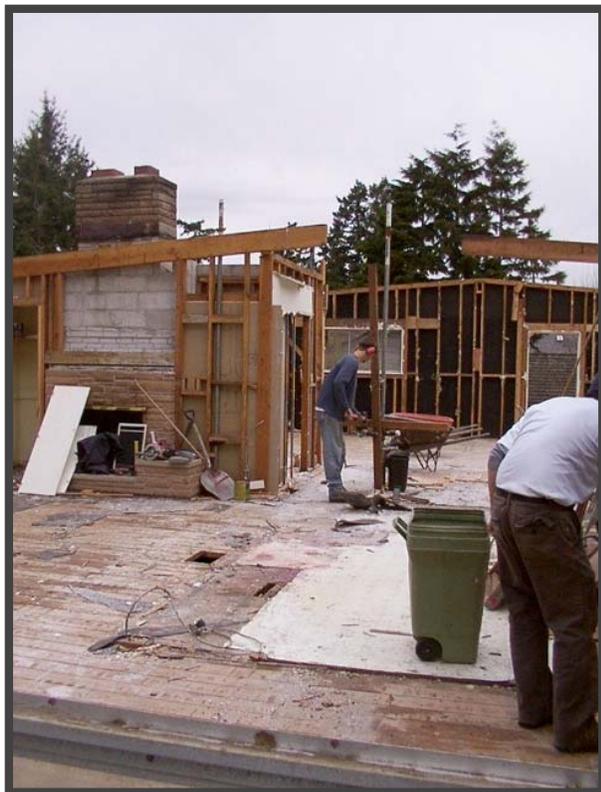
The walls comprising the shell of the structure were then collapsed and dismantled in the same fashion, utilizing ropes to pull down the larger, heavier walls, and employing supports fashioned from salvaged lumber to prevent remaining walls from falling in and harming members of the deconstruction team.
