<u>Case Study Report #2, 183 "C" St. Blaine, WA</u> <u>Commercial Building, Circa 1970</u>

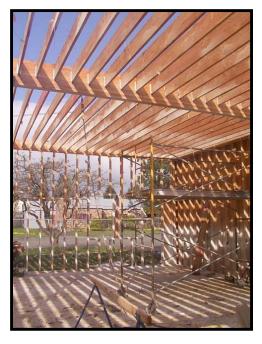
The next stage required removal of the roof structure. The flat roof was covered with several layers of rolled torch down roofing over plywood and in other areas by reusable butyl roofing. The rolled roofing was first cut into roughly 4ft. wide sections with a utility knife and/or power circular saw and then peeled from the plywood. The sections of roofing material were then dropped into a recycling bin. The butyl roofing was cut into 4'-6' wide strips and rolled and bound for resale.

The next stage involved removing the plywood from the roof supports. This was done with bars from above until it could no longer be done safely, at which time the plywood was pried from below from wheeled scaffolding. Once each piece was removed, it was handed down to a waiting crew member who moved it to a designated denailing area, where it was de-nailed and loaded onto waiting trucks by the remaining crew member/s.

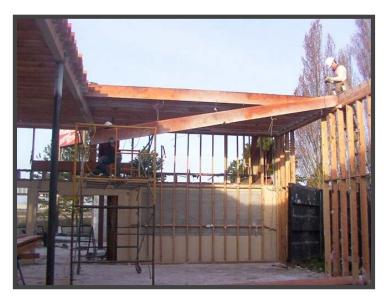
After plywood salvage, the field crew was ready to remove the 2"x 10" and 2"x 12" ceiling joists. The joists were cut from their hangers and lowered by ropes to the ground, where they were de-nailed and stacked in

anticipation of an on-site purchase and pickup. The field crew utilized a forklift to remove the remaining heavy glue-laminated support beams.

Once the roof support was completely removed, the exterior walls were ready to be collapsed. As much of the plywood sheathing was removed as possible from the shell before the exterior walls were pulled down. The walls comprising the shell of the structure were then collapsed and dismantled in the same fashion as the interior walls, utilizing ropes to pull down the larger, heavier walls, and employing supports fashioned from salvaged lumber to prevent remaining walls from falling in and harming members of the deconstruction team.
